LEARNING TO DEVELOP, INNOVATE, LIVE
AND WORK IN ANACONDA'S SUPERFUND.

STUCKY RIDGE REMEDIATION

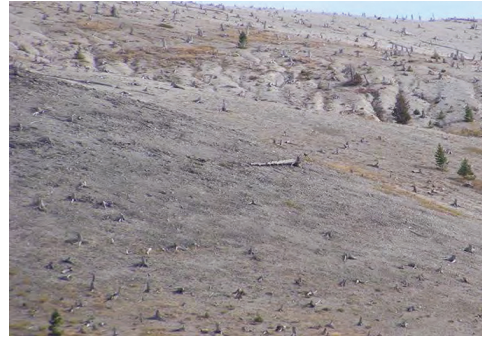
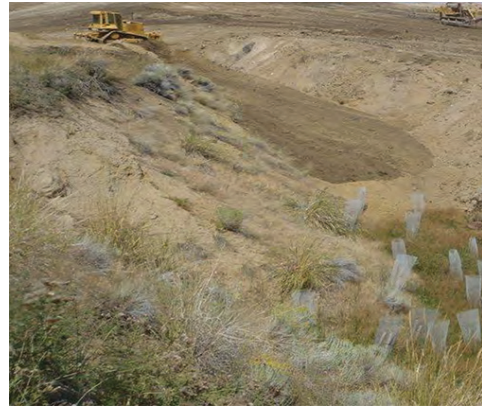
BEFORE

Stucky Ridge, located due north of the stack, was largely impacted by contaminants from the smelting operations. The Natural Resource Damage Program (NRDP) was designated areas on Stucky Ridge to remediate and restore. The remediation started in 2015 and was concluded in 2018.

NRDP used between 20-30 tons per acre of sugar beet lime to remediate this section of Stucky Ridge. NRDP also planted trees and shrubs in hard to reach areas of the hill side and in stormwater ditches. Today, the area is full of vegetation and native growth.
